West Moors Memorial Hall
Asbestos Action Plan & Status Report
22nd November 2024 – Ian Linehan

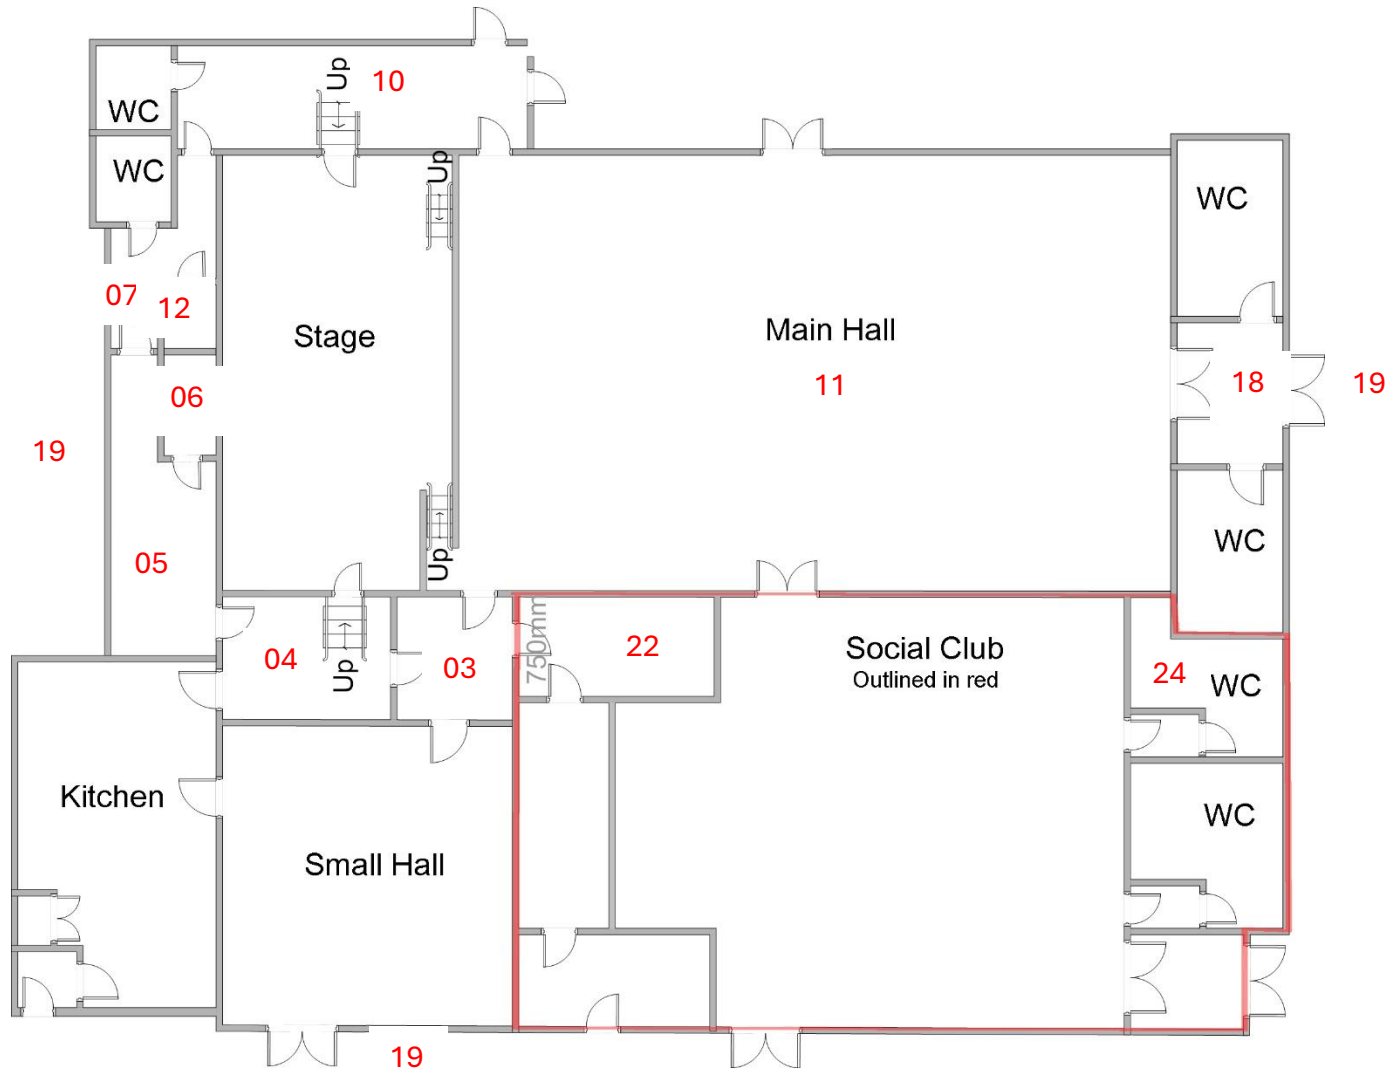
Hall Plan with Areas of Asbestos identified or suspected indicated in red. Other areas showed no evidence of asbestos.
